**EFFECTS OF FARMER-INITIATED MODIFICATIONS OF WATER
CONTROL STRUCTURES ON PERFORMANCE OF IRRIGATION SYSTEM:
A CASE STUDY OF MKINDO SCHEME, MOROGORO, TANZANIA**

**A DISSERTATION SUBMITTED IN PARTIAL FULFILMENT
FOR THE DEGREE OF MASTER OF SCIENCE IN AGRICULTURAL
ENGINEERING OF SOKOINE UNIVERSITY OF AGRICULTURE,
MOROGORO, TANZANIA**

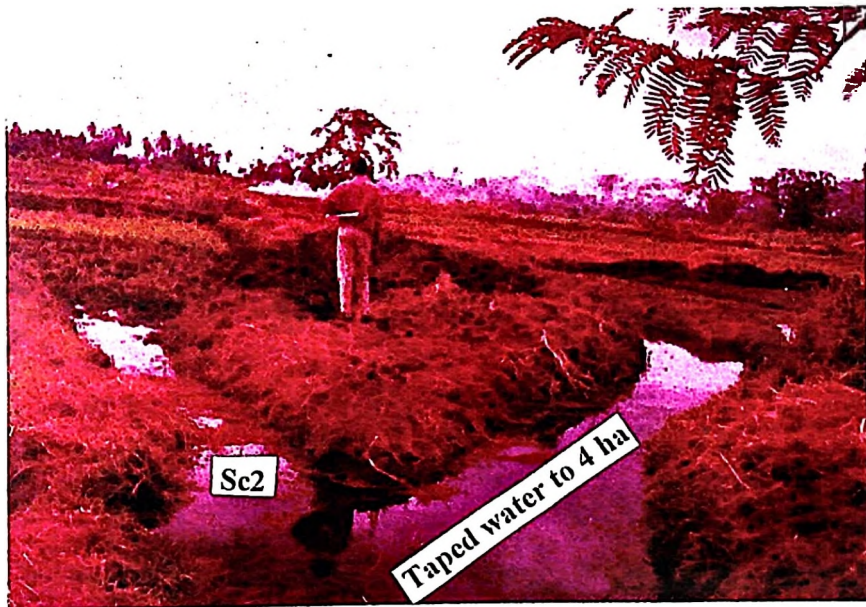
It was observed that water tapping from main canal and secondary canal by farmers outside the scheme exists as shown in Fig. 3.4, Fig. 3.5 and Plate 4.1-2, due to water/land demand for irrigation. The continuous flowing stream through the cuts made by them may widen the cross section and result in excess flow at the head reach and diminished flow at the tail end as shown in Plate 4.2. The problem was also reported by Neupane (1995) who stated that in order to distribute water from the main canal to the secondary canals or field channels in irrigation systems that they have constructed, farmers often make a simple cut in the side of the canal for water to flow through to their fields. They regulate the flow from the main canal by inserting stones or mud from the canal bank into the cut. The discharge through the cut is difficult to estimate since any irrigator can freely open a cut of any size, causing wastage of a considerable volume of water. This causes scarcity at the tail end of the command area, which brings

Plate 4.2 Irrigation water taping by farmers outside the scheme from Sc2 (Fig. 3.4)

It was observed that most of the canals were leaking through the canal banks causing soil erosion on the outside part as shown in Plate 4.2. This may be attributed to poor maintenance and design of the banks, which has led to a wrong construction causing the leakage. On the other hand, canals were choked with grass. This definitely reduced the flow capacity because the canals were designed and constructed as grassed channels. Overall condition of the canals indicate poor maintenance of the system.

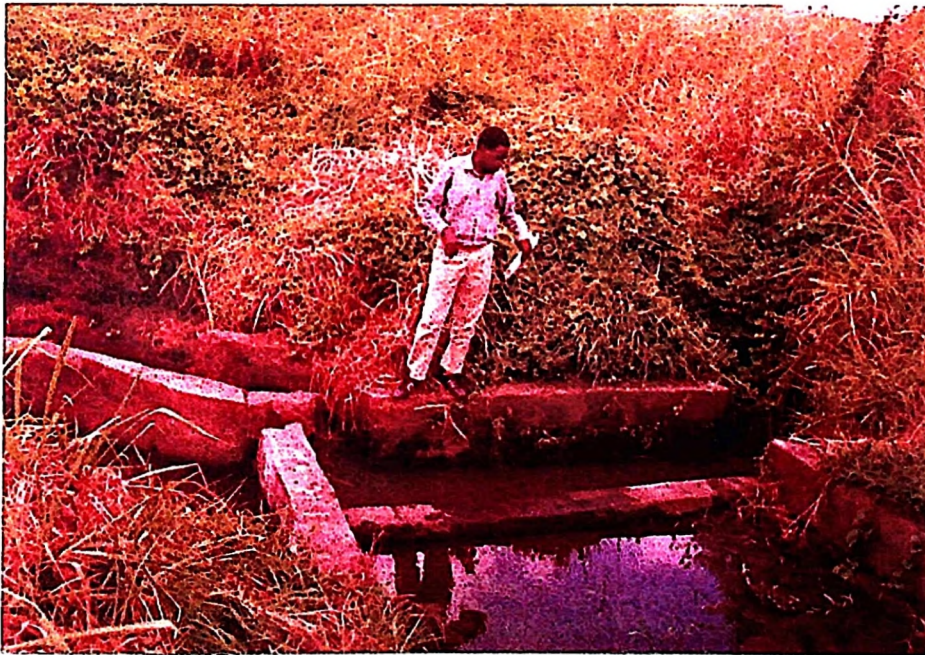
It was observed that water control gates were not existing at division box openings and at turnout level for the scheme as shown in Fig. 4.1 and Plate 4.3. Also Plate 4.3, Fig 4.1 and Fig. 4.2 shows how some of the water control structures looked like at the design/constructed stage and at the present study. Division box, apart from diverting the flow of the parent canal to another or from a canal to a tertiary canal structure by means of sluice gates or wooden stop-logs, this also served to reduce variation in water depth in the parent canal so that the abstracted discharge would be more- or-less constant for a given gate opening irrespective of the flow in the parent canal (Manzungu, 1999). In the old division box for phase-I farm area as shown in Fig. 4.2, divider wall was provided to control water entering into secondary canals (Sc1, Sc2 and Sc3). Later on farmers thought this wall was the cause of improper distribution of water among the mentioned secondary canals. Then the divider wall was removed by farmers as shown in Fig. 4.1.

However, the removal of divider wall was not a permanent solution for proper and effective distribution of water among the secondary canals in the scheme. Still exists a problem of water distribution in the scheme as discussed in various sections. However, the alternative to a problem would be the provision of proportioning water-division devices to it. It was reported by Mallya (1997) that structures if well designed and properly installed, are able to distribute the irrigation water on proportional basis in FMIS. Also it was reported by Yoder (1995) that the selection of most suitable type of water control structures such as turn out, distribution boxes, etc must take into consideration, among other factors, the operation and maintenance costs of the structure. The chosen design must be flexible to accommodate farmers' requirements; otherwise the farmers will have no alternative but to modify the structures by breaking it (Ford Foundation, 1995). This is due to the fact that our farmers do not have the knowledge of operating and maintaining them.

Plate 4.3: Typical existed layout of division box at phase-I of the scheme

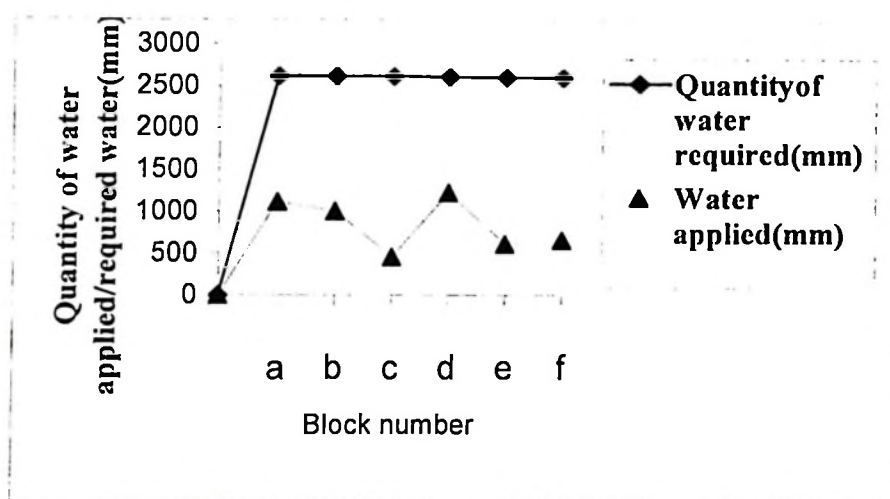
The amount of water applied in both phase-I and phase-II was generally less than the planned quantities as shown in Table 4.2 and Fig 4.3.

Fig 4.3 Quantity of water applied/required mm/ha,

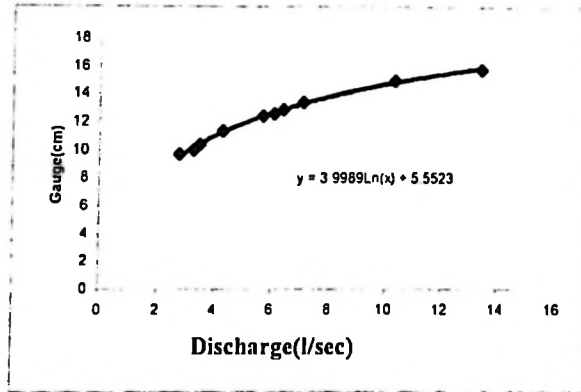
Q(l/sec)	Gauge(cm)
2.79	9.8
3.3	10.1
3.5	10.5
4.3	11.5
5.7	12.5
6.1	12.7
6.4	13
7.1	13.5
10.3	15
13.4	15.8

(b) flow rating curve for Sc1
